## Toe Cracks in Base Plate Welds – 30 Years Later

Richard Aichinger<sup>1</sup> and Warren Higgins<sup>2</sup>

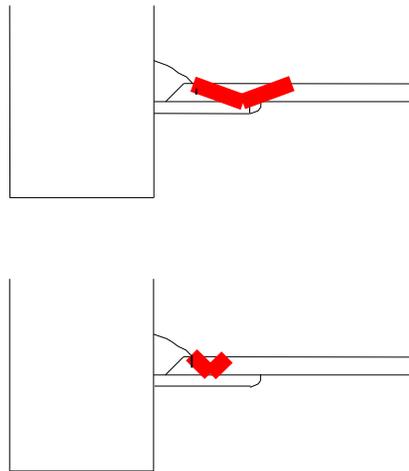
Figure 1. Inspection with a (common) 70 degree & (alternate) 45 degree transducer

Figure 1 shows the commonly used Ultrasonic Inspection (U.T.) process for our industry, derived through the application of AWS D1.1. A portion of the inspection sound can be lost in the backup seal weld. The sound does not strike the normal crack position in a perpendicular orientation, which results in additional sound loss. Although this method has been in use for many years to detect cracks in the weld joint, it requires higher scanning levels and greater technician skill.

Figure 1 also shows an alternative 45 degree inspection method that can be used to detect toe cracks with higher effectiveness. With this method, the backup bar seal weld presents no interference (a phenomenon known as “corner trap” effect returns a greater percentage of the sound back to the transducer). Because this method is more sensitive to surface conditions, it will result in more false readings rather than missed readings. This procedure requires a follow-up inspection to verify a true presence of a crack.

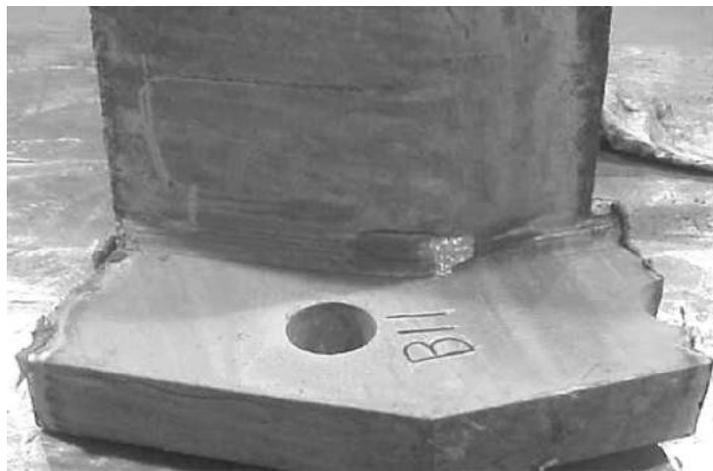
Figure 4. Investigation Sample

Each of these organizations was provided with a portion of a scrapped bottom section for review and investigation. A graphical representation of the bottom section and its distribution to the various organizations is shown in Figure 3. A picture of an actual sample sent for study is shown in Figure 4.

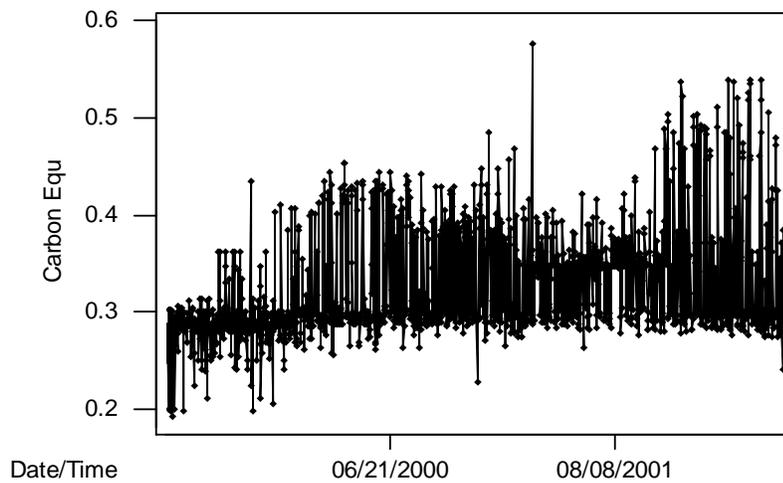
Figure 6. Carbon Equivalent Change

Figures 6, 7 & 8 show the change in the carbon equivalent (CE) value, columbium (Cb), and vanadium (V) over the time of investigation, respectively. Not only does the CE change in value, but also increases the degree of variation. The CE formula used was:  $CE = \%C + Mn/6 + (\%Cr + \% Mo + \% V)/5 + (\%Si + \%Ni + \% Cu)/15$

- Carbon equivalent (per the above formula) shall be restricted to a maximum of 0.45.
- In addition to silicon (Si) restriction to 0.06% maximum;
  - Free nitrogen (N) content shall be 50 ppm max. (aim for 40 ppm)
  - Vanadium (V) shall be 0.09% max.
- Discrete plate is preferred (particularly for thicknesses greater than 0.375”).
- Tensile strength maximum is 100 ksi (aim for 90 ksi). The “aim for” compliance will be used for vendor evaluation and performance.

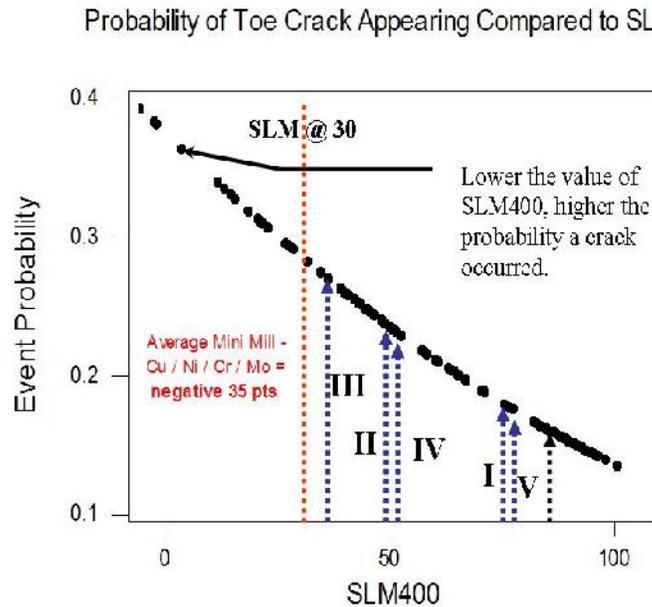
Fig. 9. Event Probability Plot of Crack Occurring Compared to SLM400

An event probability plot compared to SLM400 is represented in Figure 9.

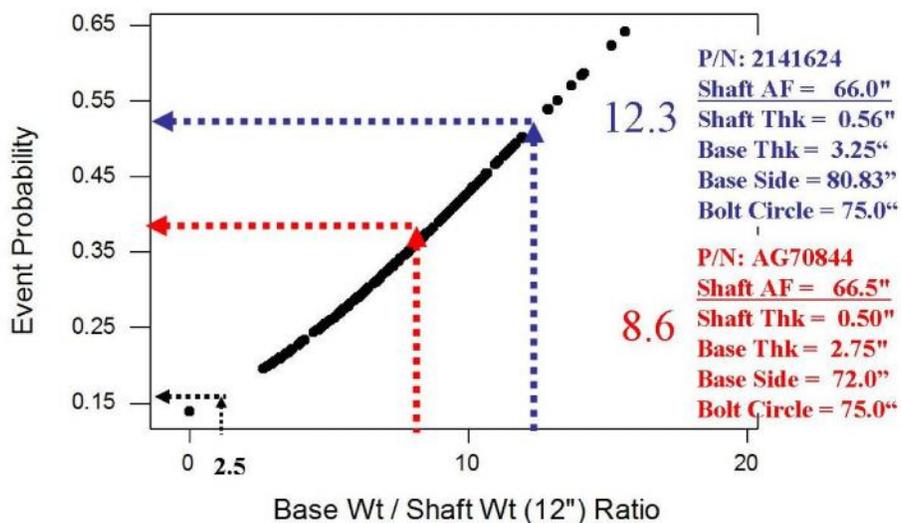
Figure 10. Probability of Toe Crack Compared to Ratio of Base Plate Weight to Shaft Weight (Bottom 12")

A relationship of the base plate weight to the pole shaft weight (bottom 12 inches) was noted in comparing designs that did and did not result in toe cracks. This weight relationship is represented in Figure 10. To a large extent the efficient design is a result of the loading and limitations provided by the Utility customer and specifically modifying the design can create significant cost impact in material utilization and fabrication labor. However, this ratio appears to be an additional consideration.
