# Discovering Outgassing Defects

Dr. Zamanzadeh, Matco Associates, Pittsburgh, PA

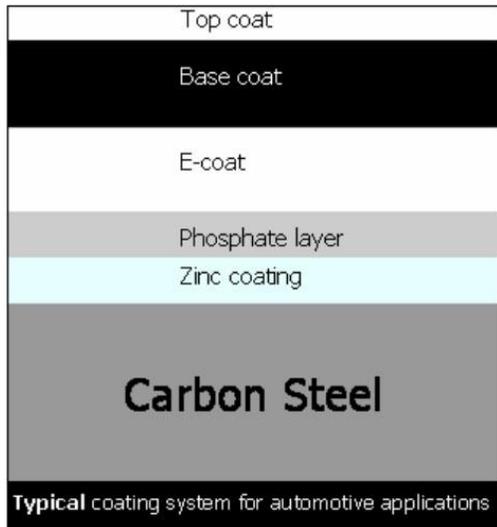
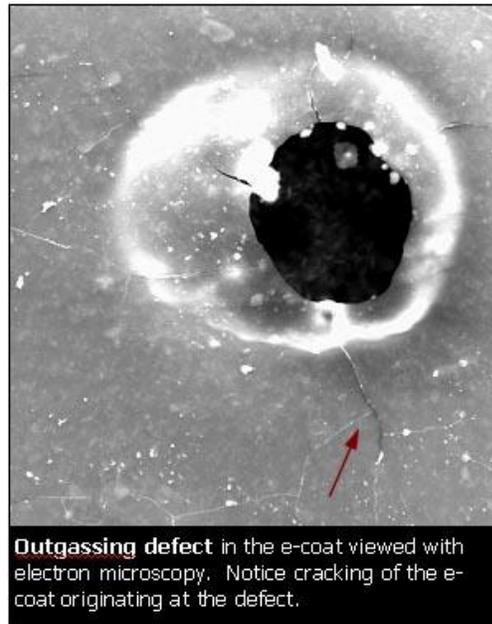
Production lines usually involve rolling, electrogalvanizing, phosphating, electrodeposition-coating and baking processes. The cross-section above illustrates these processes. Beginning with rolled carbon steel, layers are added at each step of the process. The zinc layer being formed by electrogalvanizing, the phosphate layer by phosphating, the e-coat by electrodeposition, and the final base coat and topcoat layers by common coating application techniques.

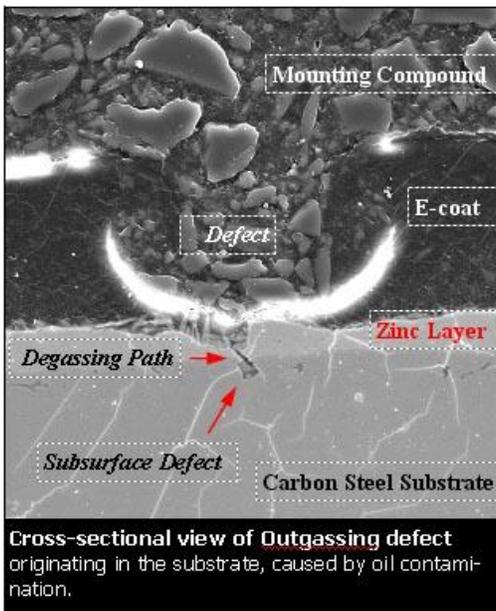
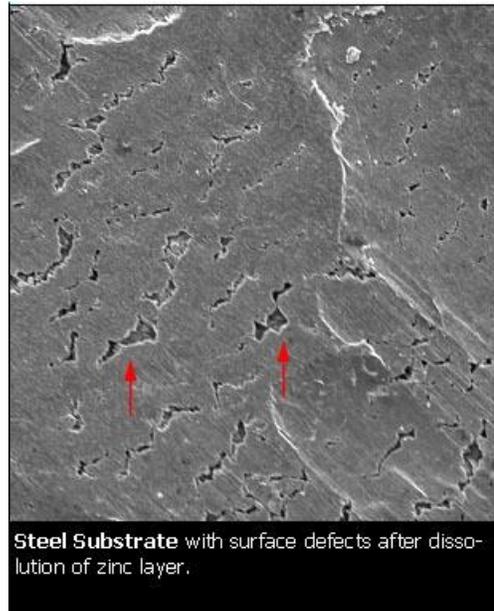
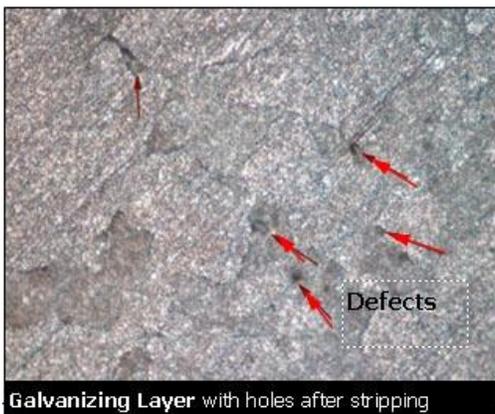
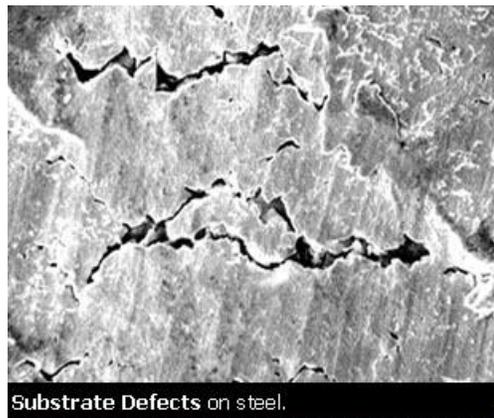
In a recent case, Matco characterized outgassing defects and resolved the issue with a comprehensive failure analysis involving FTIR, SEM/EDS and somewhat uncommon metallographic techniques. In the investigation it was found that the blister-like defects in the e-coat actually possessed some type of defective site or irregularity beneath, in the substrate. To further examine this irregularity several samples were successively polished.

Metallurgical cross sectioning and successive polishing revealed the minute popping defects to be due to small cavities, cracks, surface protrusions or flaps in the substrate. Anodic stripping of the phosphate layer and electro-galvanized layer further confirmed the metallurgical observations, and revealed the presence of numerous defects on the surface of the substrate.

Additionally an unfinished sample possessing no electrogalvanizing exhibited the same type of defect in the form of extensive surface and subsurface cracking. These sites trap oil during rolling operations. The same sites may also trap hydrogen during electro-galvanizing or pickling operations, although this aspect was not observed at the time of the investigation. Subsequent cleaning is not able to dissolve the oil because the defects are rolled over. Electro-galvanizing and phosphating covers these defective sites with oil trapped in them. The baking operation in the e-coat process releases the trapped oil during the baking stage. The thermal energy results in outgassing and micro-popping during the baking operation, which in turn results in a popping type defects in the final product.

Baking the electrogalvanized samples prior to the e-coat process releases the entrapped oil and subsequently results in an oil free part during e-coat process. This is why e-coating after prebaking does not show a defective structure. This observation further confirms the proposed failure mechanism for defective electrogalvanized e-coat parts.
