Discovering Outgassing Defects

Dr. Zamanzadeh, Matco Associates, Pittsburgh, PA

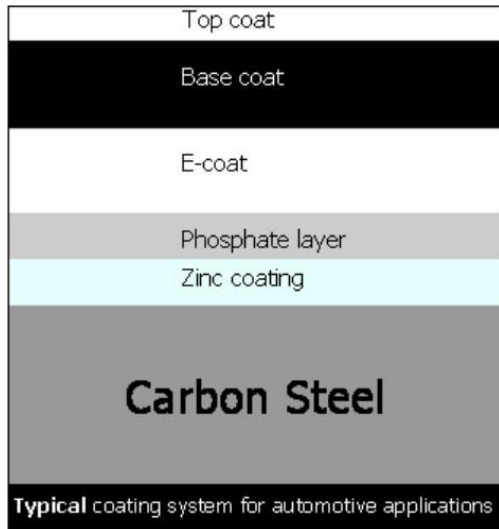
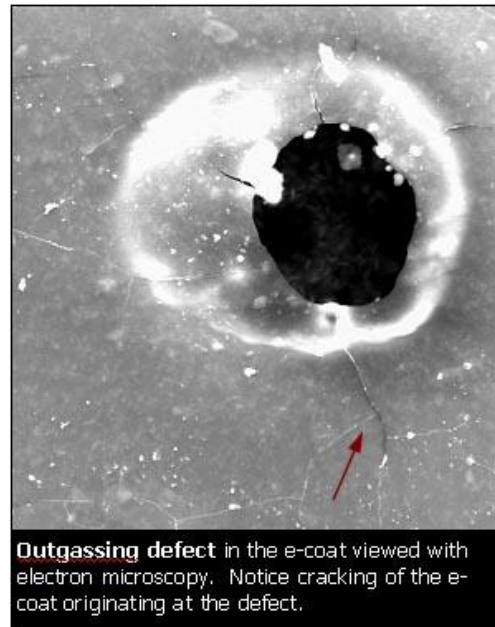
Production lines usually involve rolling, electrogalvanizing, phosphating, electrodeposition-coating and baking processes. The cross-section above illustrates these processes. Beginning with rolled carbon steel, layers are added at each step of the process. The zinc layer being formed by electrogalvanizing, the phosphate layer by phosphating, the e-coat by electrodeposition, and the final base coat and topcoat layers by common coating application techniques.

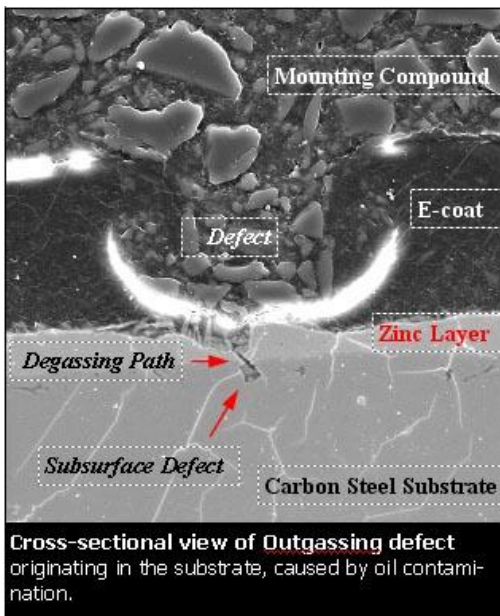
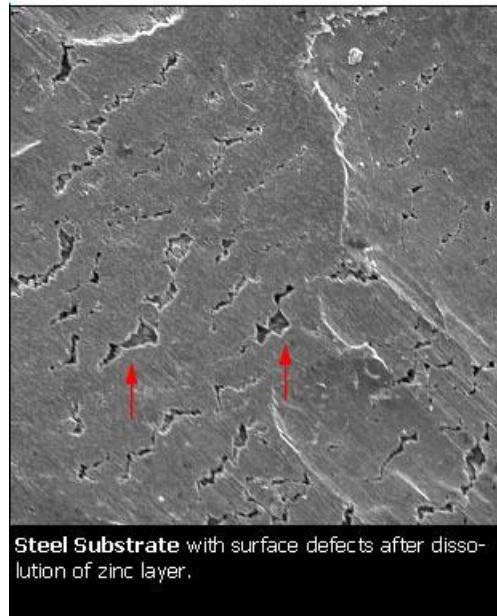
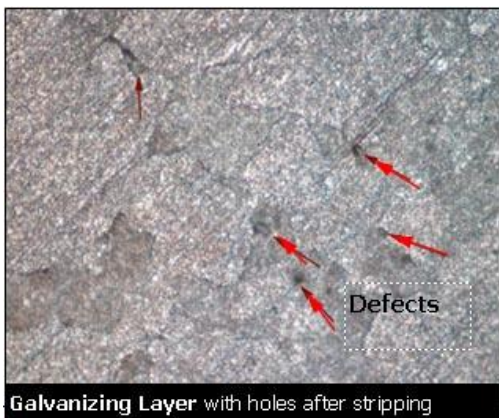
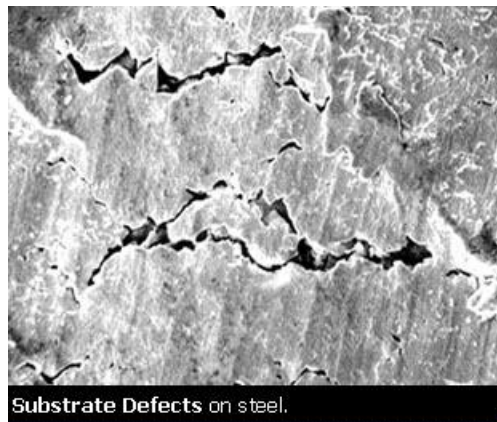
Metallurgical cross sectioning and successive polishing revealed the minute popping defects to be due to small cavities, cracks, surface protrusions or flaps in the substrate. Anodic stripping of the phosphate layer and electro-galvanized layer further confirmed the metallurgical observations, and revealed the presence of numerous defects on the surface of the substrate.

Additionally an unfinished sample possessing no electrogalvanizing exhibited the same type of defect in the form of extensive surface and subsurface cracking. These sites trap oil during rolling operations. The same sites may also trap hydrogen during electro-galvanizing or pickling operations, although this aspect was not observed at the time of the investigation. Subsequent cleaning is not able to dissolve the oil because the defects are rolled over. Electro-galvanizing and phosphating covers these defective sites with oil trapped in them. The baking operation in the e-coat process releases the trapped oil during the baking stage. The thermal energy results in outgassing and micro-popping during the baking operation, which in turn results in a popping type defects in the final product.

Baking the electrogalvanized samples prior to the e-coat process releases the entrapped oil and subsequently results in an oil free part during e-coat process. This is why e-coating after prebaking does not show a defective structure. This observation further confirms the proposed failure mechanism for defective electrogalvanized e-coat parts.
