Discovering Outgassing Defects

Dr. Zamanzadeh, Matco Associates, Pittsburgh, PA

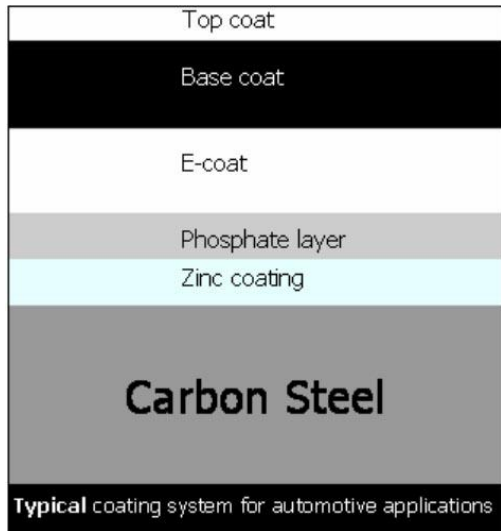
Production lines usually involve rolling, electrogalvanizing, phosphating, electrodeposition-coating and baking processes. The cross-section above illustrates these processes. Beginning with rolled carbon steel, layers are added at each step of the process. The zinc layer being formed by electrogalvanizing, the phosphate layer by phosphating, the e-coat by electrodeposition, and the final base coat and topcoat layers by common coating application techniques.
