# Some Failure Analysis Case Histories in Galvanized Steel Products

Dr. Zamanzadeh and Ed Larkin Matco Associates, Pittsburgh, PA

**Abstract:** The three case histories presented in this paper concern defects and causes of failure associated with galvanized steel sheet material. Optical metallography and microindentation hardness testing were the principal methods employed in determining the causes of failure but were supplemented as necessary by scanning electron microscopy and energy-dispersive X-ray spectrometry.

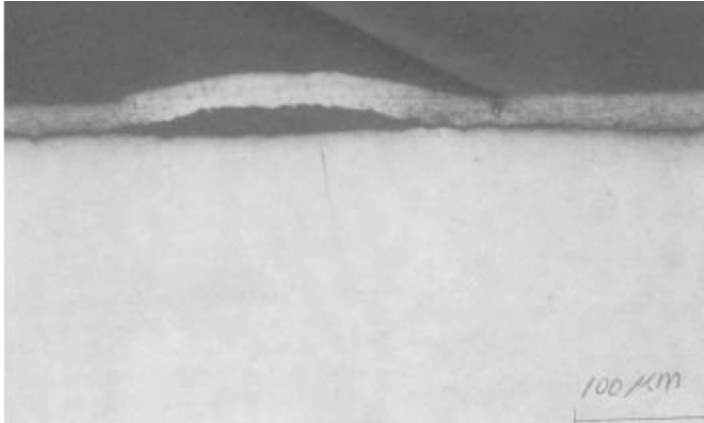
Transverse sections through the galvanized steel in the blistered areas were prepared for subsequent metallographic inspection. In the as-polished condition, the blisters were observed as small arches in the coating with complete separation occurring at the zinc-steel interface (Fig. 1). At high magnifications, small gray inclusions were observed on the steel surface within the cavity (Fig. 2). The inclusions were examined using a scanning electron microscope equipped with an energy dispersive X-ray spectrometer. Only iron was observed. The equipment cannot detect the presence of elements in the first row of the periodic table such as carbon, oxygen, nitrogen, etc. Based upon the appearance of the inclusions, and the absence of any elements other than iron, the inclusions are most likely iron oxide.

Figure 1: Photograph at 200x showing a blister under the galvanized coating as polished.

The blisters in the galvanized coating appear to have been caused by gas accumulation at the interface between the steel and the zinc coating. Iron oxide inclusions were observed within the blister cavities. The following mechanism is responsible for the blistering problem: (1) the as-received steel strip probably was incompletely pickled, which left iron-oxide scale at small isolated locations; (2) during pickling and later annealing, hydrogen was absorbed by the steel; (3) during galvanizing, the heat from the molten zinc caused the hydrogen to diffuse out of the steel; (4) at locations where surface oxides existed, the atomic hydrogen was able to recombine to form diatomic molecular hydrogen gas that raised the surface of the coating, forming the observed blisters.

To eliminate this problem, it was suggested that the surface oxides be eliminated completely. This will not prevent hydrogen absorption but should prevent the formation of gas blisters when the hydrogen diffuses out of the steel during galvanizing.

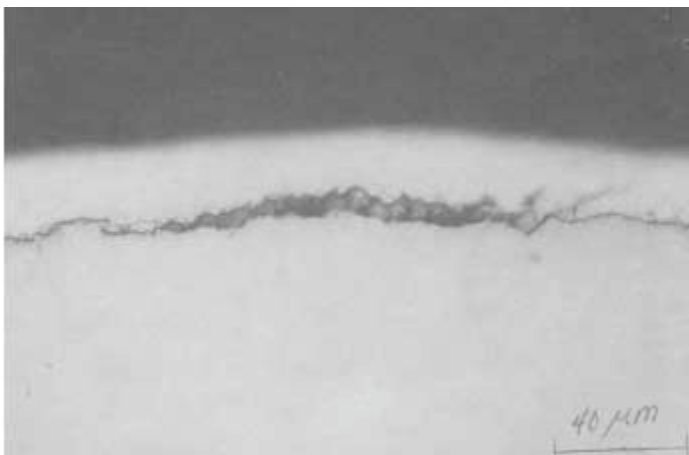
Figure 2: Photograph at 500x showing scale particles within a blister as polished.
