# Some Failure Analysis Case Histories in Galvanized Steel Products

Dr. Zamanzadeh and Ed Larkin Matco Associates, Pittsburgh, PA

**Abstract:** The three case histories presented in this paper concern defects and causes of failure associated with galvanized steel sheet material. Optical metallography and microindentation hardness testing were the principal methods employed in determining the causes of failure but were supplemented as necessary by scanning electron microscopy and energy-dispersive X-ray spectrometry.

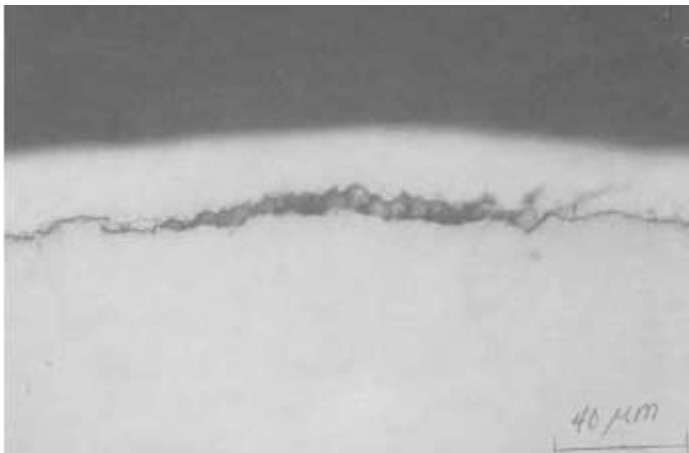
Figure 2: Photograph at 500x showing scale particles within a blister as polished.

The blisters in the galvanized coating appear to have been caused by gas accumulation at the interface between the steel and the zinc coating. Iron oxide inclusions were observed within the blister cavities. The following mechanism is responsible for the blistering problem: (1) the as-received steel strip probably was incompletely pickled, which left iron-oxide scale at small isolated locations; (2) during pickling and later annealing, hydrogen was absorbed by the steel; (3) during galvanizing, the heat from the molten zinc caused the hydrogen to diffuse out of the steel; (4) at locations where surface oxides existed, the atomic hydrogen was able to recombine to form diatomic molecular hydrogen gas that raised the surface of the coating, forming the observed blisters.

To eliminate this problem, it was suggested that the surface oxides be eliminated completely. This will not prevent hydrogen absorption but should prevent the formation of gas blisters when the hydrogen diffuses out of the steel during galvanizing.
