## White Rust (Storage Stain) on Galvanized Coatings.

# White Rust (Storage Stain) on Galvanized Coatings

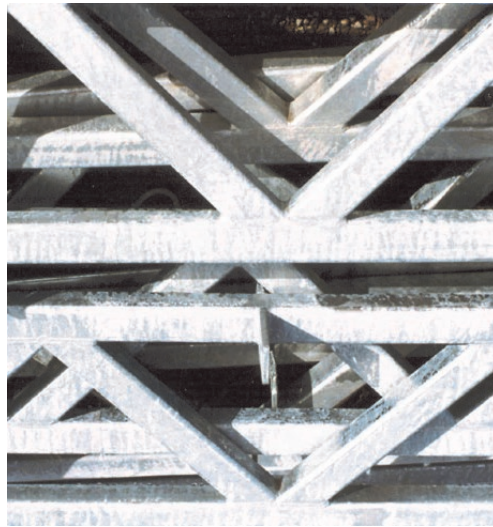
**Storage stain on newly galvanized work.** So-called white rust forms when freshly galvanized steel is exposed to water in a deficiency of oxygen.
