What causes Delamination Of Galvanized Coatings?

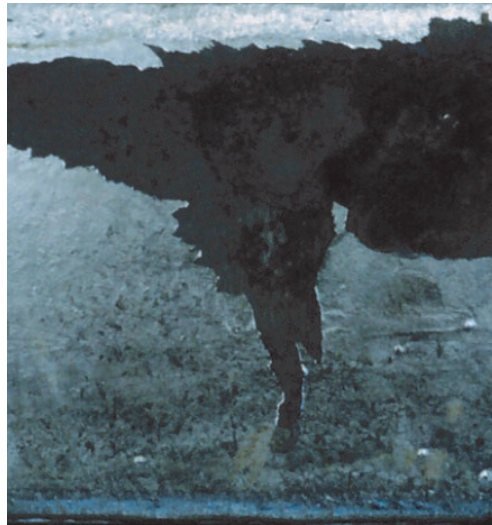
Delamination of galvanized coating. Causes include steel chemistry, cooling cycle or mechanical stress of susceptible coatings.

The most common cause of galvanized coating delamination is 'heat peeling'. This occurs when the steel, usually heavy section thickness, is cooled slowly or is not cooled sufficiently in the quenching process, causing residual heat in the steel mass to reheat the coating.

The thermal stresses generated by this differential heating or cooling will create high shear forces at the steel/coating interface, resulting in localised delamination of the coating.

- Cool the item as consistently as possible after galvanizing. Ensure that the item is fully cooled in the quenching process and residual heat in thick sections will not re-heat the coating.
- Where fabrications need to be air-cooled, ensure they are placed in well-ventilated areas so the individual items are not subject to radiant heat from adjacent items.

When galvanized coatings delaminate, there is always a thin zinc-iron alloy layer (the gamma layer) remaining in the surface so corrosion is unlikely to occur in the short term. Remediation of the delaminated area can be done with an approved epoxy zinc-rich paint repair system.
