## Galvanized Coatings Appearance & Defects

The Australian Standard AS 4680:2006 - *Hot Dipped Galvanized Coatings on Ferrous Articles*, provides guidance regarding defects. It states that, galvanized coatings shall be:-

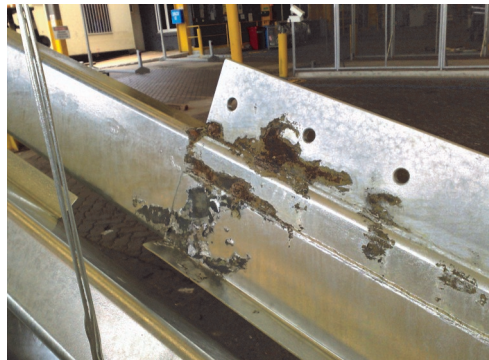
'Blowout': Unsealed welds where preparation chemicals penetrate the overlap cause blowouts, which cause surface defects and contamination.

### Dark Staining Adjacent to Welds ('Blowout', or 'Welding Blowout')

Galvanizing preparation chemicals entering unsealed overlaps, or through poor quality welds, will boil out of the connection when dipped in the molten zinc (450°C). This can cause surface contamination and coating misses during galvanizing. To avoid welding blowouts, check weld areas for complete welds to insure there is no fluid penetration (though remember any air trapped in hollow sections or between welded plates needs to vent to avoid distortion). Products can be preheated prior to immersion into the galvanizing kettle to dry out overlap areas as much as possible. Blowouts that cause bare areas should be repaired according to the Australian Standard.

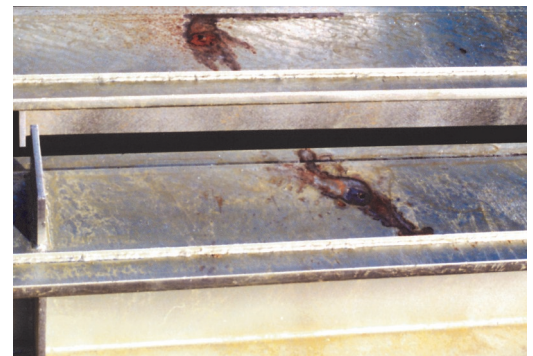
Flux staining: should be washed off to reveal a sound coating and is not usually grounds for rejection of the work.

### Flux Staining

Any anhydrous (dried) fluxing salts left in the connection will absorb atmospheric moisture and leach out onto the adjacent galvanized surface. The affected area should be washed clean with water to remove the slightly corrosive leachate. Correct design of the overlapping plate joint can avoid this problem.

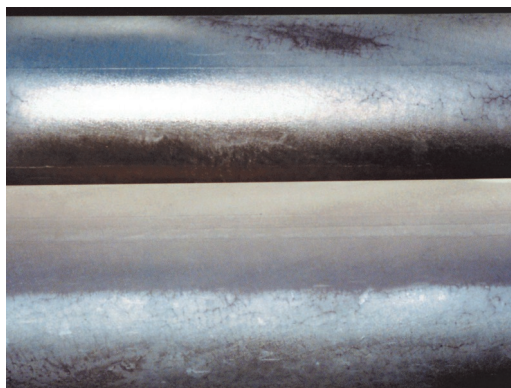
Dull grey coatings usually occur on steels - or at welds - with higher silicon content

### Dull Grey Coating

Caused by growth of the protective zinc-iron alloy layer through to the surface, and may be localized or appear as a lacework pattern on an otherwise normal coating. Dull grey coatings are often thicker than bright or spangled coatings, and will give longer life. It is difficult for the galvanizer to control the development of dull grey coatings but they can be overcome by using appropriate steel grade.

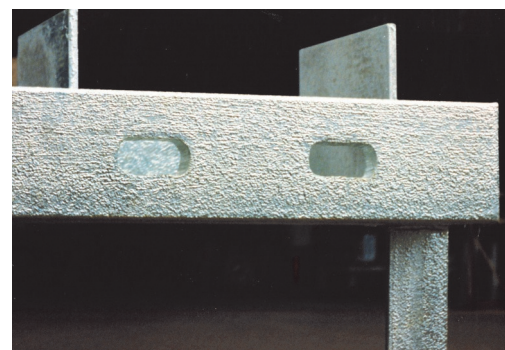
Rough coating surface is not necessarily detrimental to coating performance

This is usually the result of the composition or surface condition of the steel. The galvanized coating on welds may be thicker where high-silicon welding electrodes have been used. Other causes include over-pickling, prolonged immersion in the zinc bath or excessive bath temperature. Generally the coating is acceptable unless aesthetics are of concern.

### General Roughness

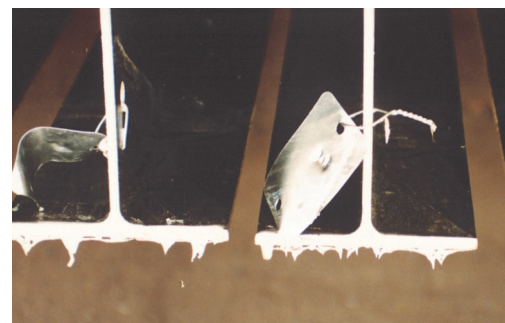
Drainage spikes formed when molten zinc freezes should be removed by the galvanizer during dressing and inspection.

### Lumpiness, Runs and Spikes

A perfectly smooth hot dip galvanized finish is unattainable; in practice lumps and runs from uneven drainage are not detrimental to coating life. Zinc drainage spikes should be removed from galvanized articles where they present a danger in handling or use.
