## Galvanizing and Coal - 45 Years' Experience.

### Case History Performance

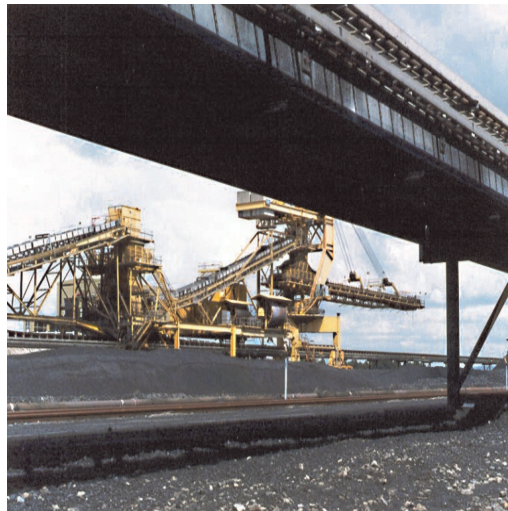
**Coal loader.** Over 40 years of field testing shows that galvanized coatings perform well in harsh mining environments.

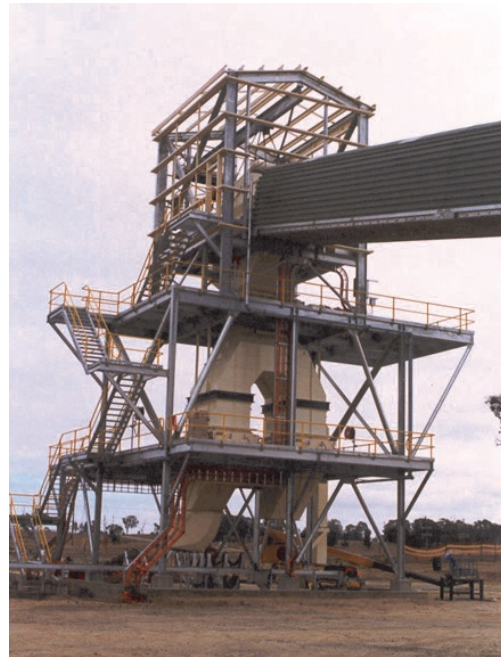
Projects undertaken in Central Queensland, such as the North Goonyella Mine development, which commenced operation in the early 1990's have had galvanized coating performance audits conducted after 12 years of operation. These audits found no significant deterioration of the coating with the likelihood of a maintenance free service life of the structural steelwork in the coal treatment plant exceeding 50 years.
